Revision
04/25/22

2RZ/3RZ Teflon Throttle Body Gasket (Part #1032099)

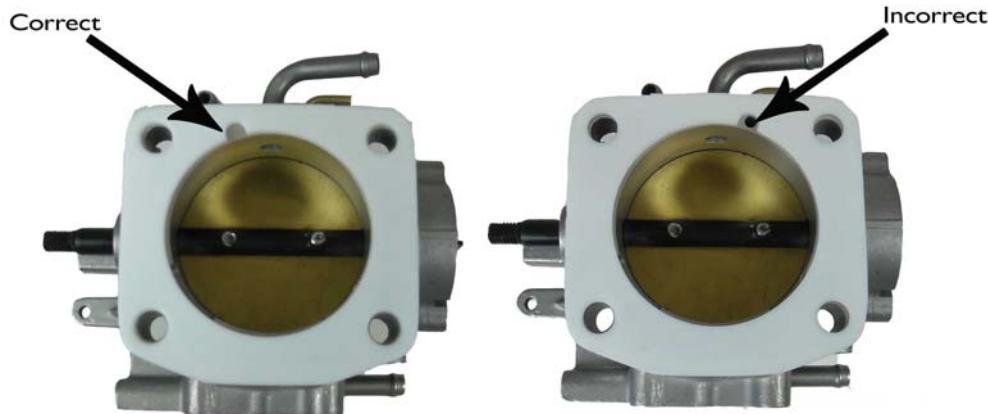
On the Teflon throttle body gasket there is a small notch cut out of the center hole of the gasket. This notch must be installed as shown below. Failure to install it properly will result in running issues.

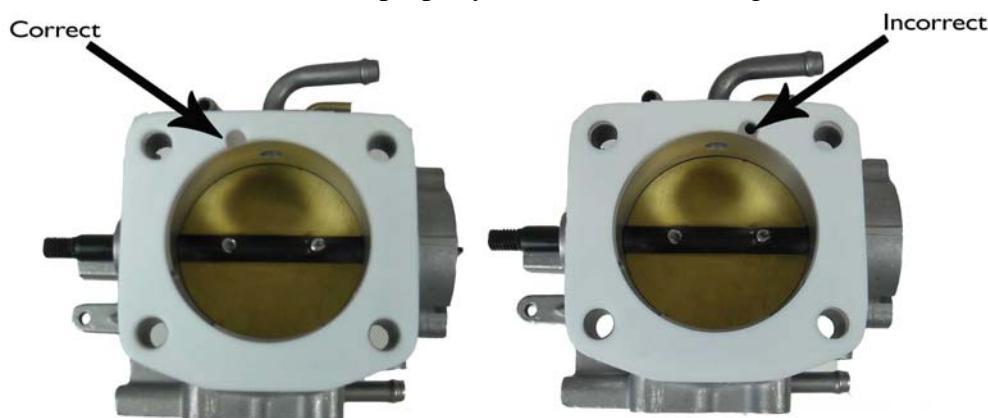
On the Teflon throttle body gasket there is a small notch cut out of the center hole of the gasket. This notch must be installed as shown below. Failure to install it properly will result in running issues.
